Warm Springs Preserve

Joint Council and P&Z Meeting

November 15, 2022

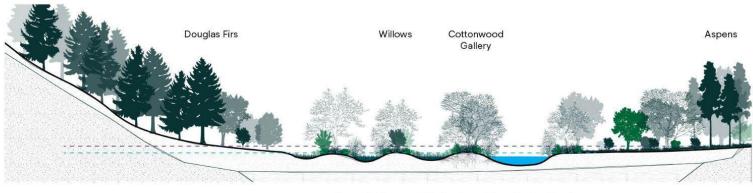
Alluvial Floodplain Pre-1800

In this condition, the area where Warm Springs Preserve currently exists acted as an alluvial floodplain containing multiple meandering streams and floodable areas.

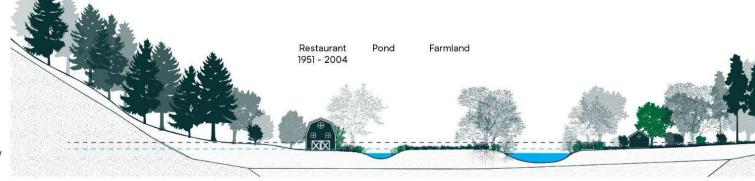
Farm + Restaurant 1800 - 1950s

As people moved to the area and used the land for other purposes such as farming and recreation, the floodplain was lost.

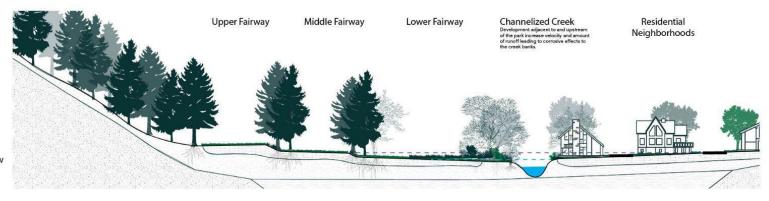
Golf Course 1960 - 2009

Intensified development has limited the creek's natural ability to move and flood healthily. As the development and weather patterns change, the threat to residents and the creek itself will intensify.

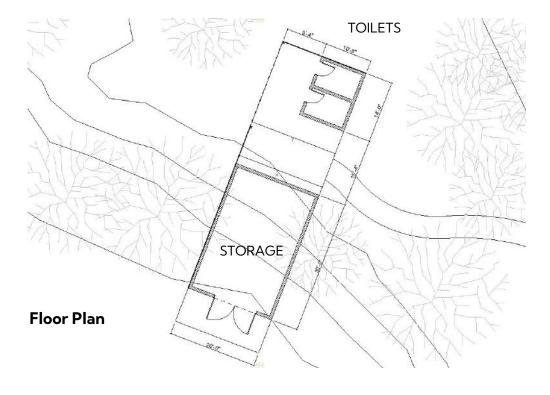
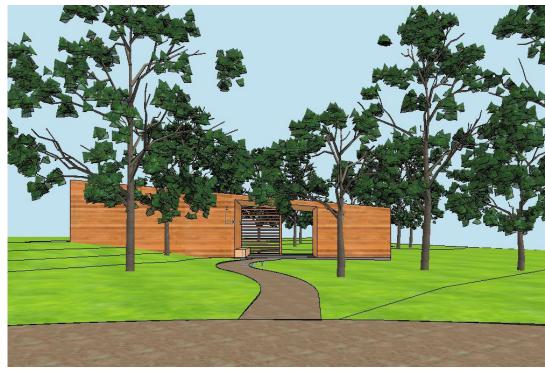
Restroom & Storage Building

The proposed restroom and storage building will be compact and efficient while providing needed services and facilities to support the preserve. It will include two (2) toilets for year round use, storage for maintenance, water fountains for people and dogs, waste receptacles, donor wall to recognize community supporters, a trail map, bike racks and sheltered seating. This concept provides ample screening by placing the small structure in the existing grove of trees and augmenting the grove with additional screening.

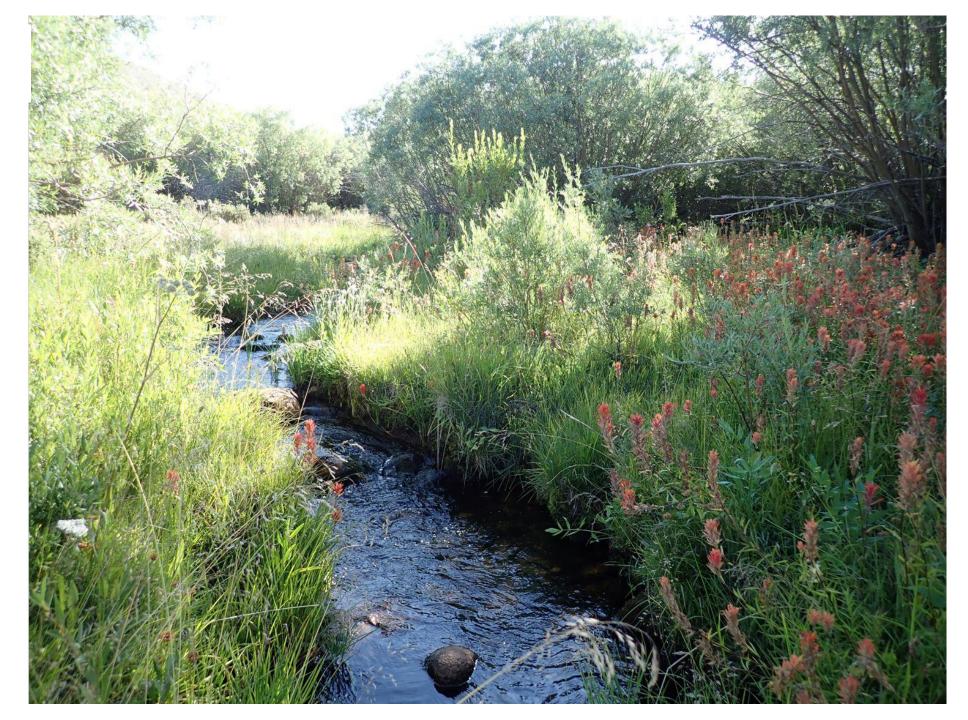
Natural Side Channel, with Mature Vegetation

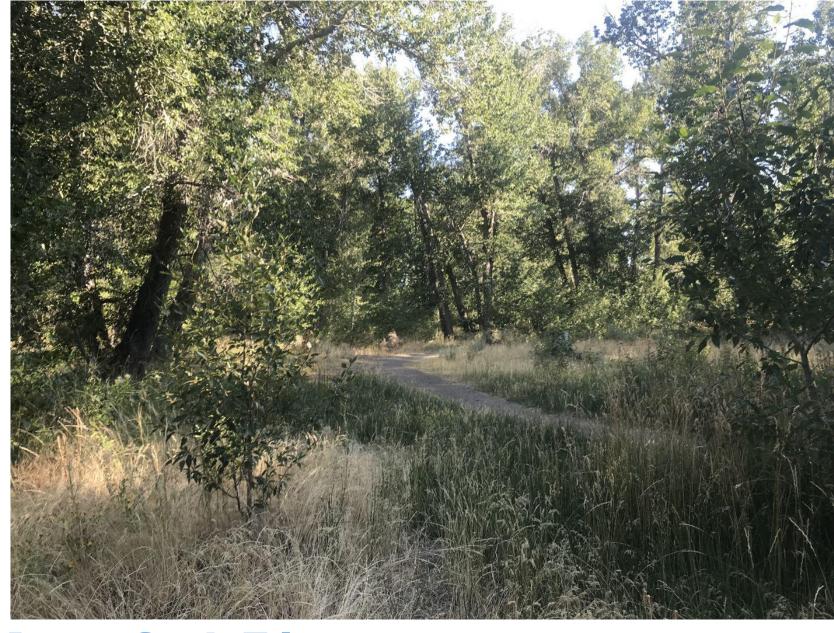
Natural Floodplain, with Mature Vegetation (Colorado Gulch)

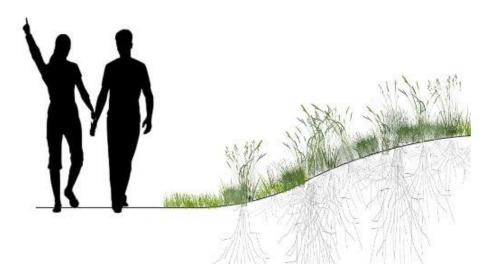
Example section showing berms with native grasses, forbs and shrubs.

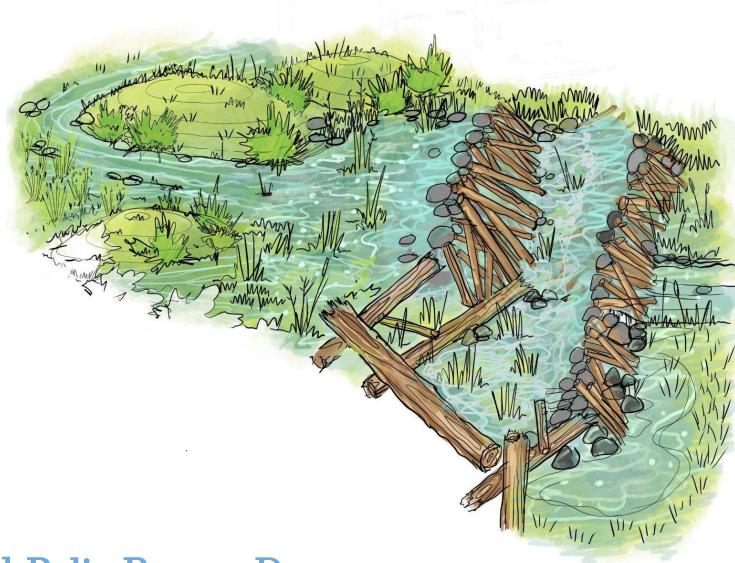
Constructed Relic Beaver Dam

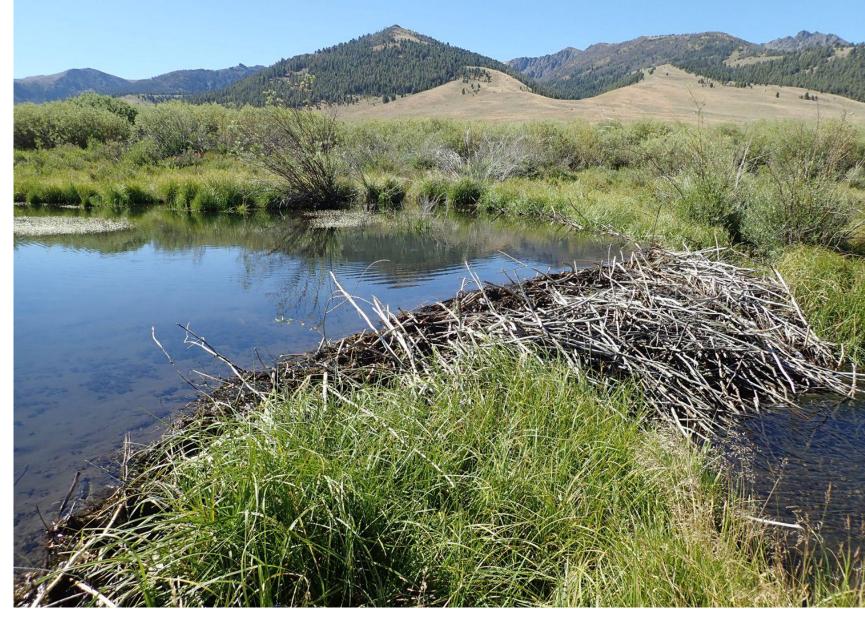
Natural Beaver Dam, made from rock, soil and willow branches
